Hearing Date COA# INDIANAPOLIS HISTORIC PRESERVATION AUG. 4, 2010 **COMMISSION** 2010-COA-192 (CAMA) STAFF REPORT 612 East 9<sup>th</sup> Street Continued from: July 7, 2010 CHATHAM-ARCH MASSACHUSETTS AVENUE Applicant PATRICIA BIDDINGER 612 East 9<sup>th</sup> Street mailing address: Indianapolis, IN 46202 Owner: Same as above Center Twp. Council District 9 **CASE** Jackie Nytes Retain siding as installed on garage not in compliance with **IHPC COA:** 2010-COA-192 (CAMA) previously issued COA. STAFF RECOMMENDATION: Approval of staff recommended compromise, or Denial

## STAFF COMMENTS

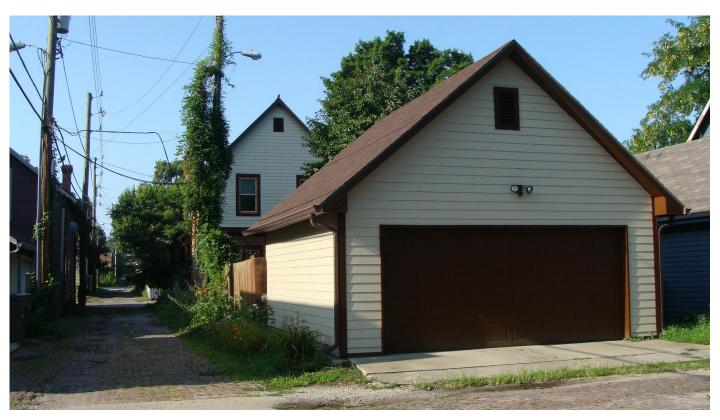
The applicant was informed that the siding installed on the detached garage is not considered "appropriate." The applicant applied to retain the siding as-is. Staff recommended the applicant either plane down (sand) the surface of the fiber cement siding or replace the siding with new material with a smooth surface texture.

View of detached garage seen from the intersection of the rear alleys

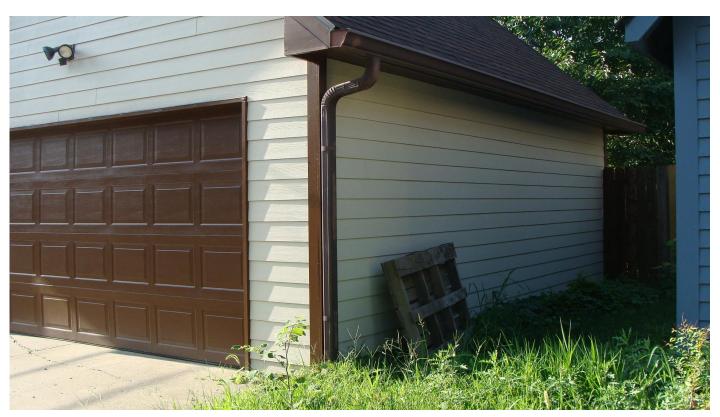
View looking at the northwest corner of the garage seen from the alley

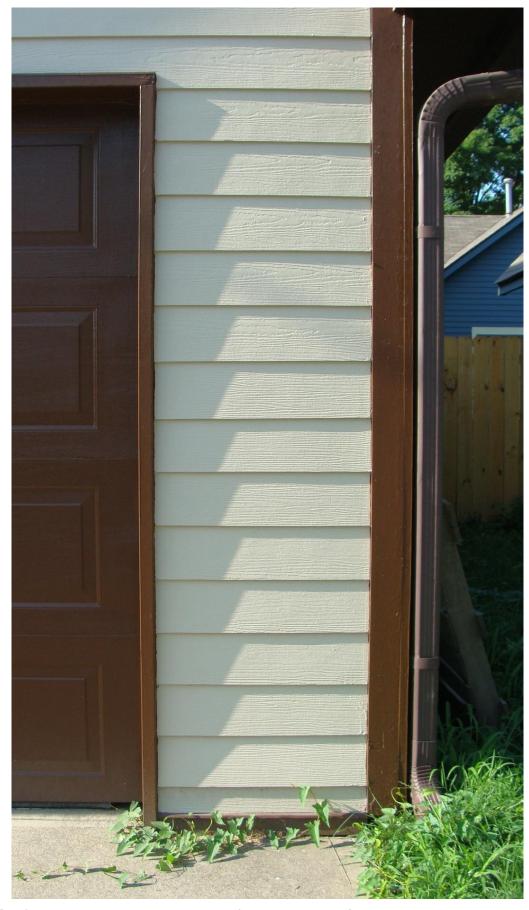
The siding that was approved on the upper floor of the house and the detached garage was a fiber cement siding with a smooth, ungrained surface texture. The Chatham-Arch Massachusetts Avenue Plan specifically recommends "new architectural elements added to a non-historic building should be of a simple design compatible with the building and not visually intrusive within the district". The siding installed on the detached garage is Hardie-Plank with an embossed wood grain surface texture. This heavy graining effect is not consistent with the visual quality of smooth sanded siding traditionally found in the historic area. The commission has consistently rejected this siding since it developed its "hardboard siding" policy in the mid 1980s. The use of the embossed siding is very visible on the detached garage from the alleys. Its use will have a substantial visual effect on the building.

Detail of rough-sawn embossed surface texture evident on the detached garage

- 1. Two-coats of Porter-Flex Elastomeric Patching Compound must be applied on the surface of all existing textured siding on the garage to give the siding the appearance of a smooth surface texture.
- 2. The patching compound shall create a smooth surface free of apparent trowel lines or marks.

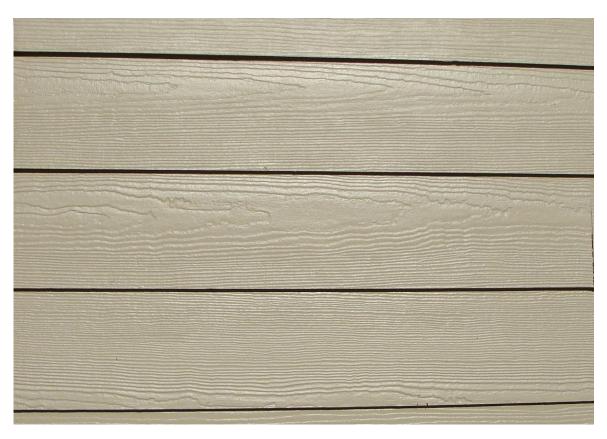
Close up view of siding texture

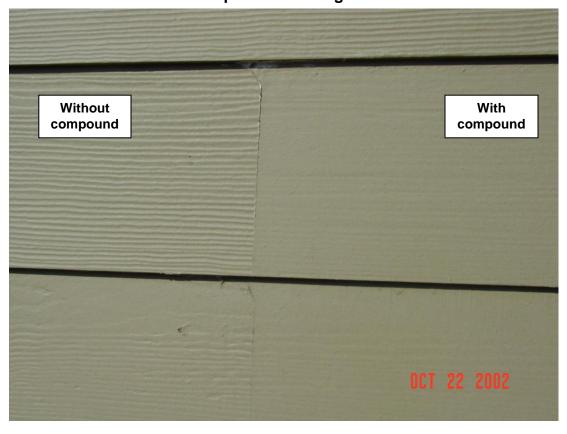
Staff recently proposed to the applicant to apply a product called Porter-Flex Elastomeric Patching Compound over the existing textured siding. This is a product that was approved by the Commission in November, 2002 on a similar project where embossed rough-sawn fiber cement siding was installed in non-compliance in the Saint Joseph (SJ) Historic District. A picture of the siding from the SJ project with and without the patching compound is in this staff report. Staff has viewed the completed installation of the compound material and finds the result to be visually

acceptable in mitigating the effect of the siding. If the same compound is applied to this detached garage, the embossed rough-sawn texture of the siding could be visually diminished to a point that a Certificate of Authorization could be justified for insubstantial effect. The cost of applying the compound material is about \$6900 including painting. Total replacement of the siding on the detached garage is estimated to be \$9700 including painting. Sanding the surface of the fiber cement siding is an alteration that is believed to void the warranty of the product and is therefore not feasible for the property owner. Cost is a motivating factor for the applicant to request the retention of the existing embossed siding as is.

View of siding with and without Elastomeric Patching Compound on similar property in St. Joseph Historic District approved in November 2002
